Confidential Inspection Report

38671 Vista Rock
Murrieta , CA 92563

PROPERTY INSPECTION REPORT

Report# 100719SR3

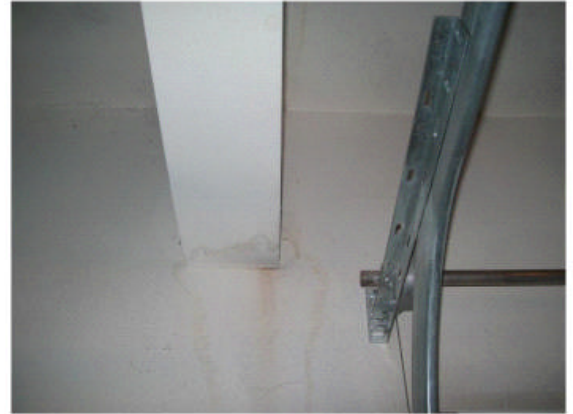
6.2 Ceiling

1. **Repair:** Moisture stains were noted on the garage ceiling and wall in the garage (the deck and roof is above this area). The area appeared dry during the inspection. Repair as needed.

Repair: Moisture stains were noted on the garage ceiling and wall in the garage. The area appeared dry during the inspection. Repair as needed.

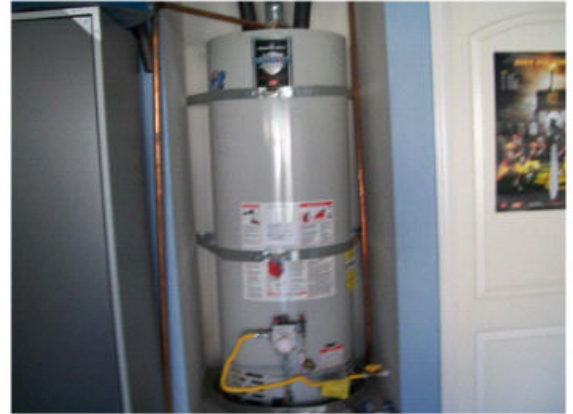
8.1 Singular Location

The location of the water heater was in the garage. The energy source for the water heater was natural gas and the storage capacity of the tank was 50 gallons.

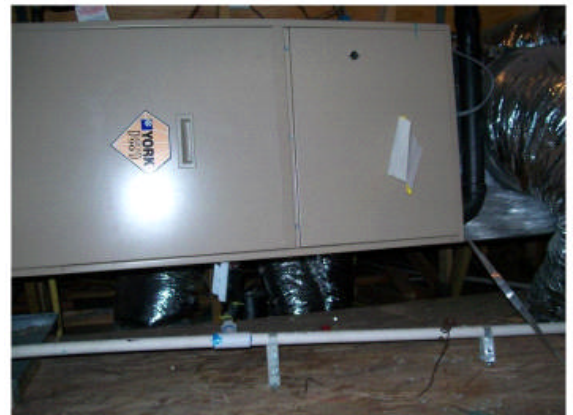
9.1 Location And Number Of Units

One heating unit/system was present, The location for heating unit # 1 is in the attic.

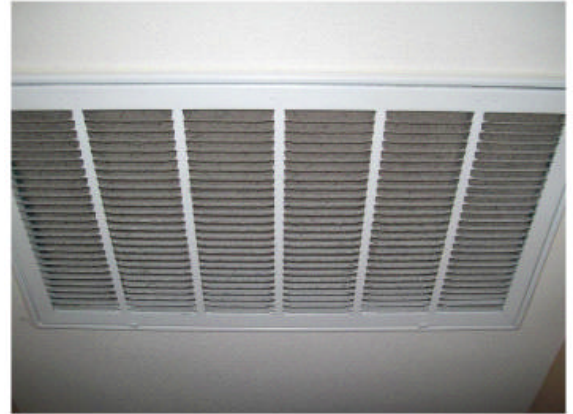
9.2 Filters

2. **Further Evaluation:** The air filter is, dirty. These conditions restrict the air flow and reduce the system's efficiency. Repair as needed.

Further Evaluation: The air filter is, dirty. These conditions restrict the air flow and reduce the system's efficiency. Repair as needed.

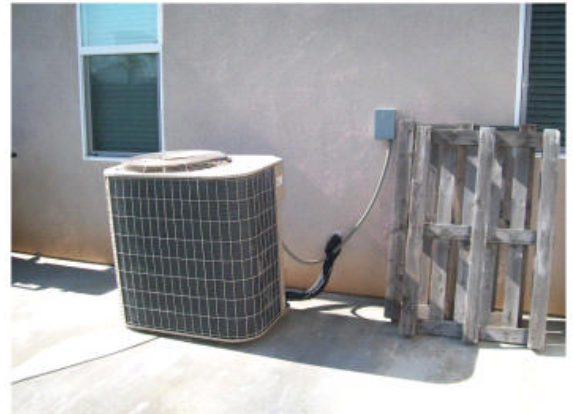
9.3 Location & Number of units

One cooling unit/system was present, The unit was located on the left side of the building.

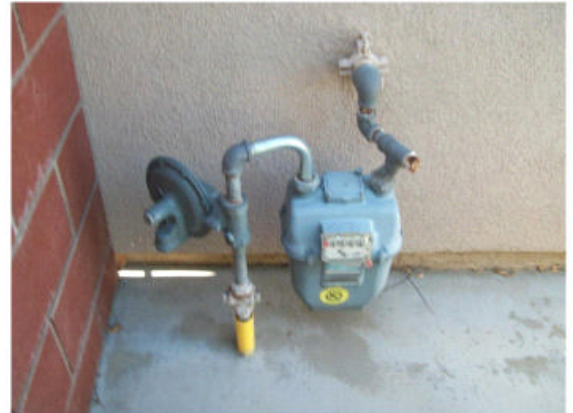
10.10 Location

The gas meter was located at the left side of the building. The main gas supply shut-off valve was located on the riser pipe between the ground and the meter.

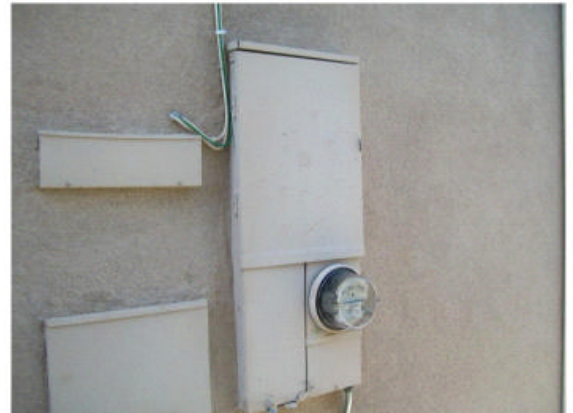
The electric meter and exterior main panel were observed to be in satisfactory condition and securely attached. The electric meter and main panel were located on the building's exterior left side.

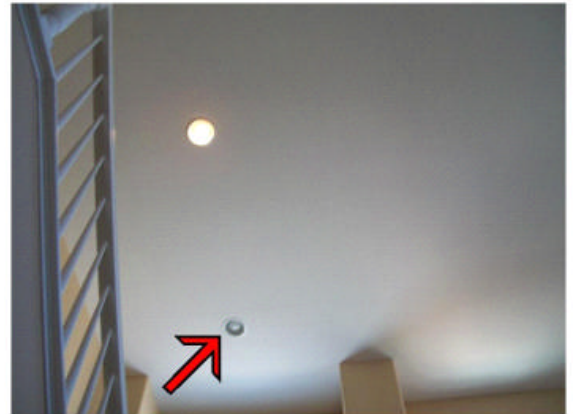
11.9 Lights Condition

3. **Repair:** The light fixture at the in the stair area was not functioning using the normal operating controls. The bulb(s) in this fixture may be burned out. If the bulbs are not burned out, the condition of the fixture and wiring should be verified. We recommend repair as necessary to restore the function of this fixture.

Repair: The light fixture at the in the stair area was not functioning using the normal operating controls. The bulb(s) in this fixture may be burned out. If the bulbs are not burned out, the condition of the fixture and wiring should be verified. We recommend repair as necessary to restore the function of this fixture.

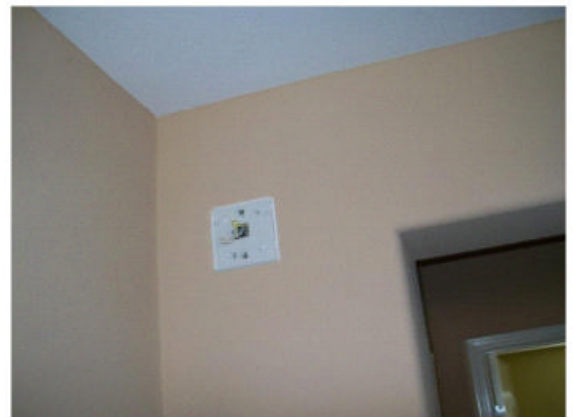
11.10 Smoke Alarms

4. **Safety Concern:** Missing smoke alarms outside the bedrooms in the upper hall area. Repair as needed for safety.

Safety Concern: Missing smoke alarms outside the bedrooms in the upper hall area. Repair as needed for safety.
